# Computational Aerodynamics of Shuttle Orbiter Damage Scenarios in Support of the Columbia **Accident Investigation**

Karen L. Bibb\* NASA Langley Research Center, Hampton, VA 23681

In support of the Columbia Accident Investigation, inviscid computations of the aerodynamic characteristics for various Shuttle Orbiter damage scenarios were performed using the Felisa unstructured CFD solver. Computed delta aerodynamics were compared with the reconstructed delta aerodynamics in order to postulate a progression of damage through the flight trajectory. By performing computations at hypervelocity flight and CF<sub>4</sub> tunnel conditions, a bridge was provided between wind tunnel testing in Langley's 20-Inch CF<sub>4</sub> facility and the flight environment experienced by Columbia during re-entry. The rapid modeling capability of the unstructured methodology allowed the computational effort to keep pace with the wind tunnel and, at times, guide the wind tunnel efforts. These computations provided a detailed view of the flowfield characteristics and the contribution of orbiter components (such as the vertical tail and wing) to aerodynamic forces and moments that were unavailable from

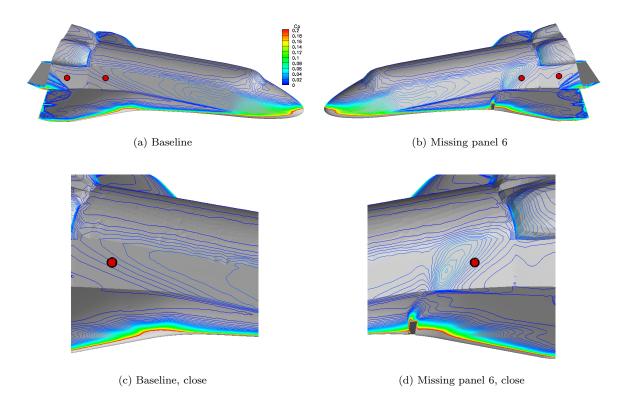
The surface  $C_p$  distributions on the windside of the vehicle for the baseline and damaged configurations at STS-2 Condition B are shown in Figure 5. The windward side showed only localized influence of the presence of the notch. The corresponding surface  $C_p$  distributions on the fuselage side for the baseline and damaged configurations are shown in Fig. 6, with a compressed scale for  $C_p$ . The wing leeside and fuselage side show a strong footprint of a jet-like structure in the flow coming from the notch, then turning toward and impinging on the fuselage side. This impingement would increase the heating rate on the fuselage side, a trend that was identified by the OI flight data early in the investigation.

Figure 6. Surface pressure  $(C_p)$  distribution, baseline and missing RCC panel 6, STS-2 condition B, with location of side fuselage bondline sensors marked

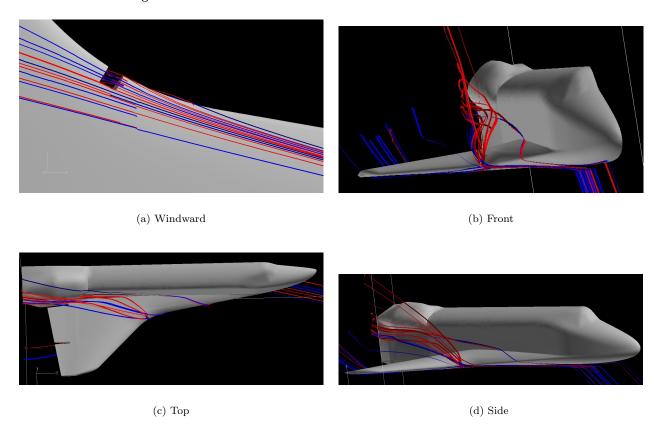
Streamlines for the baseline and missing RCC panel 6 at STS-2 Condition B are shown in Fig. 7, superimposed on the right side of the vehicle. Baseline streamlines are blue; streamlines for the damaged configuration are red. The streamlines on the windward side (Figure 7(a)) of the vehicle show that the flow pattern is not affected inboard of the missing panel. The higher

energy flow from the windward side is clearly channeled through the notch to the leeside, forming a jet-like

Figure 7. Streamlines, baseline (blue) and missing RCC panel 6 (red), STS-2 condition B

flow structure. This jet-like flow carries substantially higher energy than the surrounding leeside flow, and therefore is not significantly influenced by the baseline flow. Figure 7(c) shows the flow through the notch turning almost perpendicular to the fuselage before impinging on it. The jet then turns downstream toward the OMS pod. The baseline streamlines from the flow coming over the wing leading edge do not reach the OMS pods.

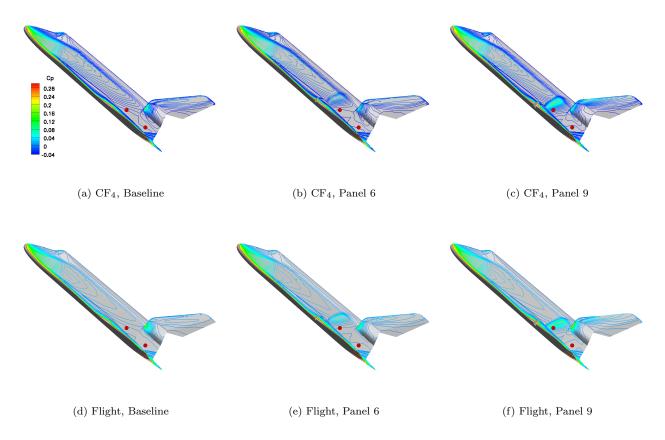
In order to understand how the  $CF_4$  flowfield compares to the flight environment, side fuselage  $C_p$  contours, shown in Fig. 16, are examined for the baseline, missing panel 6, and missing panel 9 configurations

at both flight (CFD Condition 2) and CF<sub>4</sub> tunnel conditions. The two red dots on the side fuselage indicate the approximate location of the two bondline sensors that showed a higher than nominal temperature rise

prior to loss of signal. The flight condition produces a higher overall pressure level than the  $CF_4$  conditions. The disturbance on the side fuselage is located further downstream for the  $CF_4$  cases than for flight. It is stronger and further downstream for the panel 9 cases as compared to panel 6. While the disturbance is somewhat different in location and strength between flight and  $CF_4$ , the overall character of

the disturbance is similar. This suggests that tests in the CF<sub>4</sub> tunnel provide a reasonably good simulation of the changes in surface pressure due to WLE damage scenarios at flight conditions.

Figure 16. Surface pressure  $(C_p)$  distributions for baseline, missing RCC panel 6, and missing RCC panel 9 at flight (CFD condition 2) and CF<sub>4</sub> conditions (location of side fuselage bondline sensors designated)

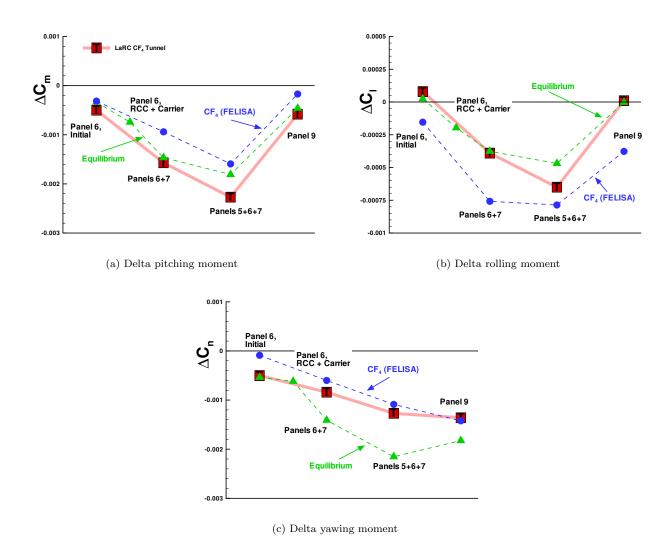
The delta aerodynamic moments computed with Felisa for several panel out configurations at flight (CFD condition 2) and CF<sub>4</sub> are compared to CF<sub>4</sub> tunnel data in Fig. 17. The x-axis of the plot is simply

Figure 17. Delta aerodynamics for full RCC panel(s) missing configurations, Felisa equilibrium (CFD Condition 2), Felisa  $CF_4$ , and  $CF_4$  tunnel data

the configuration (labeled individually). The lines connecting the points for each configuration are included only to illustrate the trends; there is no expectation that interim damages can be predicted. Magnitudes of the predicted aerodynamic moments varied with the geometry, and to a lesser degree with flow condition (Mach 6 air, CF<sub>4</sub>, and flight). As additional RCC panels are removed (panel 6, then 6+7, then 5+6+7), the moment increments become more negative. For the two single missing panel cases (panel 6 and 9),  $\Delta C_m$  and  $\Delta C_l$  remain relatively constant while  $\Delta C_n$  decreases significantly from panel 6 to panel 9. A single Felisa solution at flight (CFD condition 2) was computed for the full missing RCC panel 6 (RCC + carrier panel) to compare to the initial, or notched panel 6 results. There is a noticeable decrease in  $\Delta C_m$  and  $\Delta C_l$ , and less effect on  $\Delta C_n$ . The results suggest that removing more material at the same location has a noticeable negative impact on  $\Delta C_m$  and  $\Delta C_l$ , and less effect on  $\Delta C_n$ .

Overall, the qualitative agreement between the computations and the tunnel data is excellent, although there are differences in magnitude. Comparing the computed  $CF_4$  values (blue) to the measured data (red), FELISA predicts a larger negative  $\Delta C_l$ , smaller negative  $\Delta C_m$ , and closely agrees with  $\Delta C_n$ . When comparing flight (equilibrium air) to  $CF_4$  predictions, the flight computations produce consistently larger negative pitch and yaw increments, while predicting smaller negative rolling moment increments. While these differences appear large on the scales plotted in Fig. 17, the magnitude of all of the delta moments for the missing panel configurations represent very small aerodynamic values. The level of correlation between the flight and  $CF_4$  computations and the wind tunnel data shown in Fig. 17 strongly suggest that the trends shown in the wind tunnel results are valid for STS-107 flight conditions.

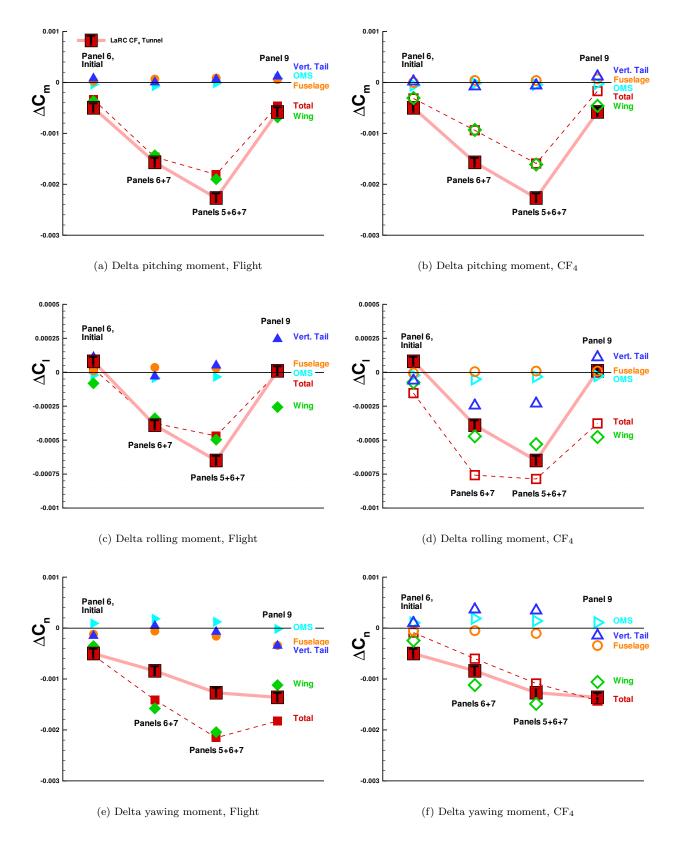
Figure 18. Component breakdown of delta aerodynamics for full RCC panel(s) missing configurations, Felisa equilibrium (CFD Condition 2), Felisa CF<sub>4</sub>, and CF<sub>4</sub> tunnel

The contributions of the vertical tail, wing, OMS pod, and fuselage regions of the Orbiter (as defined in Fig. 12) to the total delta aerodynamic moments for missing panel configurations at flight conditions (CFD condition 2, solid symbols) and CF<sub>4</sub> tunnel conditions (hollow symbols) are shown in Figure 18. Also shown are the measured aerodynamic moments for the CF<sub>4</sub> tunnel. As in Fig. 17, the missing panel configuration is plotted along the x-axis. Each component is color coded according to the colors in Fig. 12, and labeled on the plot, with the solid symbols representing flight computations.

Figures 18(a) and 18(b) clearly show that the  $\Delta C_m$  due to the wing dominates the total delta pitching moment for both flight and CF<sub>4</sub> conditions. For the multiple missing panel cases (6+7, 5+6+7) at flight conditions, Figs. 18(c) and 18(e) show that the delta rolling and yawing moments are also dominated by the wing. For the single missing panels, however, the influences of the vertical tail and wing balance each other in roll, essentially yielding a zero total increment. The vertical tail, the fuselage and the wing all produce negative increments for yawing moment, thereby providing a relatively large, negative delta yawing moment. The vertical tail contributions are more pronounced in flight for missing panel 9 than for missing panel 6. For CF<sub>4</sub> conditions (Figs. 18(d) and 18(f)), the vertical tail gives a positive contribution to  $\Delta C_l$  and a negative contribution to  $\Delta C_n$  only for missing panel 9, and these contributions are small. Overall the component breakdown results indicate that, for these configurations, there is not a large enough delta rolling moment contribution from the vertical tail to cause a substantial positive (right wing down) total delta rolling moment as seen late in flight.

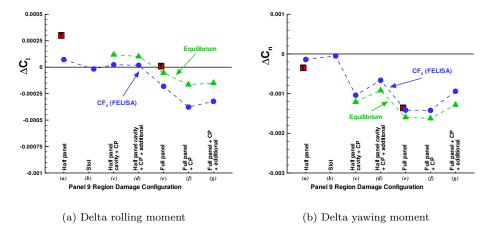
The delta rolling and yawing moments for FE-LISA cases with progressive damage in the RCC panel 9 region, at flight (CFD condition 4) and  $CF_4$  conditions, are shown in Fig. 22. Note that in order to focus on providing a plausible progression of damage that correlates with the STS-107 flight reconstruction, only the delta rolling and yawing moments will be presented for the remainder of the damage configurations. The half panel 9 geometry (a)gives a very small increment in rolling (positive) and yawing (negative) moments, as no windward flow is diverted to the leeside. The delta aerodynamics for the one inch wide slot at RCC panel 9, (b), are essentially zero. Opening a larger flow path by removing the whole upper

Figure 22. Delta rolling and yawing moments for partial panel 9 damage progression configurations, Felisa equilibrium (CFD Condition 2), Felisa  $CF_4$ , and  $CF_4$  tunnel

carrier panel 9 ( $\sim$ 190  $in^2$ ), configuration (c), does not change  $\Delta C_l$  and significantly shifts the yawing moment to a more negative value. When the size of the opening on the leeside is increased to  $\sim$ 1000  $in^2$  (configuration

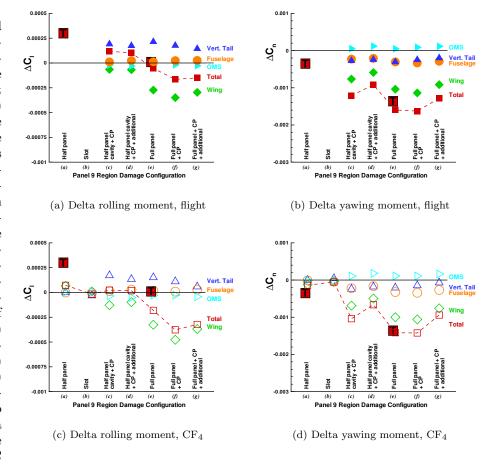
Figure 23. Component breakdown of delta rolling and yawing moments for partial panel 9 damage progression configurations, Felisa equilibrium (CFD Condition 2), Felisa  $\mathbf{CF}_4$ , and  $\mathbf{CF}_4$  tunnel

The component breakdown of the contributions to the delta aerodynamic moments is shown in Fig. 23 for flight (CFD Condition 4) and CF<sub>4</sub> tunnel conditions. (Refer to Fig. 12 for the component definition). The contributions from the OMS pod and the side fuselage are small. The vertical tail gives a consistently positive  $\Delta C_l$  contribution, which is offset to some degree by the wing. The half panel cases ((c) and (d)) have only a small contribution from the wing, and thus a positive rolling moment. The full panel cases ((e) - (g)) have larger contributions from the wing, resulting in a slightly negative rolling moment. The OMS pod, vertical tail, and fuselage give relatively consistent contributions to  $\Delta C_n$  for all half panel and full panel cases. The variation in  $\Delta C_n$  is due to the wing contribution. This analysis of component contributions to the total delta aerodynamics shows that a large positive roll does not come from the flow over the vertical tail, even when significant flow is directed toward the vertical tail.

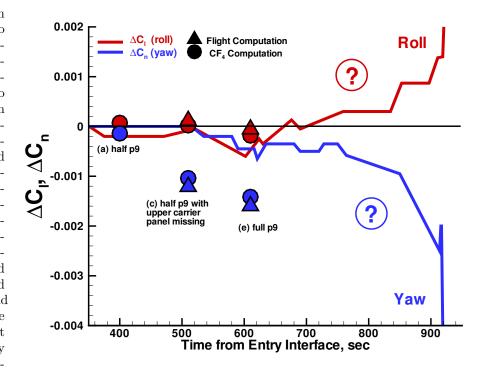
The rolling and vawing moments for a sequence of damage from a half-panel missing to a half-panel and upper carrier panel missing to a full panel missing (configurations (a) to (c) to (e)) are shown in Fig. 24 with the reconstructed aerodynamics from Fig. 1 (solid The times aslines). signed to each damage scenario were chosen such that the damage progression was consistent with specific STS-107 flight events and with aerodynamic and aerothermodynamic wind tunnel results. leeside flow fields (not shown) suggest that any of the damage progression configurations that allow flow to the leeside ((c) - (q)) produce a sig-

Figure 24. Delta rolling and yawing moments for a progressive damage scenario, through 600 seconds past EI

nificant disturbance on the fuse lage side and OMS pod, which would in turn produce higher than normal heating rates. The aerodynamic data, however, indicate that the configurations that produce the most positive delta rolling moment (albeit near zero) are configurations (c) and (d), the ones with only partial damage to the RCC panel and a flow path to the wing leeside. Since partial damage cannot occur after full RCC panel damage, and the reconstructed aerodynamics from Fig. 1 show that until 600 seconds past EI the rolling moment was trending negative, the partial panel damage must have occurred early in the flight. The current set of damage scenarios did not produce a large positive rolling moment increment as observed late flight (EI+800 sec). It is clear that progressively damaging a particular RCC panel does not produce the steady increasing trend in rolling moment increment seen in flight. This suggests that, in addition to the WLE damage, there must be another type of damage that would explain the trend reversal in the delta rolling moment.

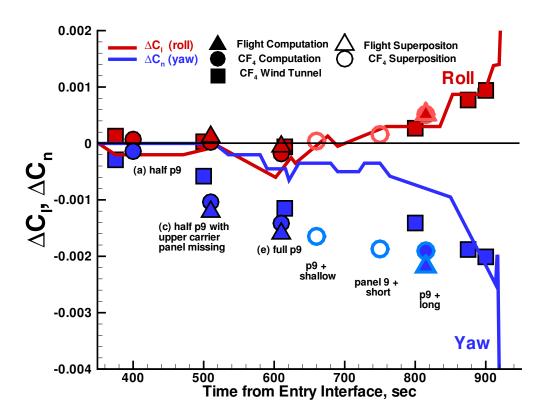
The aerodynamics for the various damage scenarios are put together to show a plausible progression of damage that produces delta aerodynamics consistent with the flight delta aerodynamics. A consistent damage progression is developed by including the delta aerodynamics from selected windward surface deformation configurations in Fig. 24. The delta aerodynamics for the final damage progression scenario developed utilizing the Felisa computations is shown in Figure 28. On entry, there was only minor damage in the RCC panel 9 region. This damage grew until around 500 seconds after EI, when a hole approximately the size of an upper carrier panel began to channel flow to the vehicle leeside. By 600 seconds past EI, the entire RCC panel was missing, and structural deformation of the wing surface began. As the internal structure degraded, and the deformation to the windside surface of the vehicle increased, the trend in rolling moment reverses to positive. Near 900 seconds past EI, something catastrophic occurred, overwhelming the control system. While the specific Felisa configurations focus on the panel 9 region, the results would have been similar for neighboring panels. (Note that the final scenario developed by the CAIB<sup>22, 23</sup> focuses on the panel 8 region, primarily due to forensic evidence.)

Figure 28. Delta rolling and yawing moments for a progressive damage scenario
